NBSIR 84-2949

Advanced Thin Film Thermocouples

October 1984

Prepared for
National Aeronautics and Space Administration
Lewis Research Center
Cleveland, OH 44135

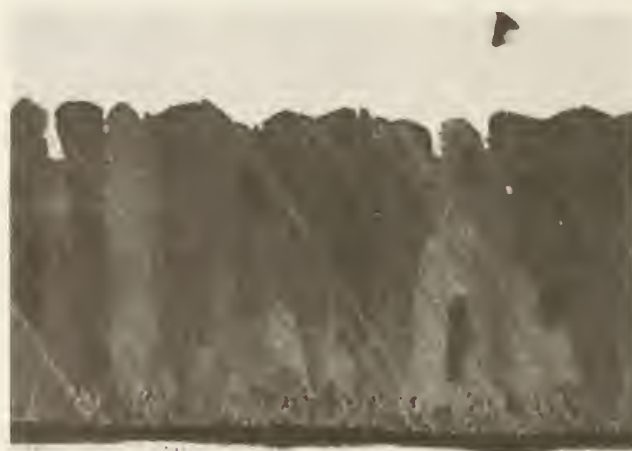
Figure 4. Sputtered FeCrAlY coating on Ni alloy Ni backing on top. Notice faceted growth (1000x)

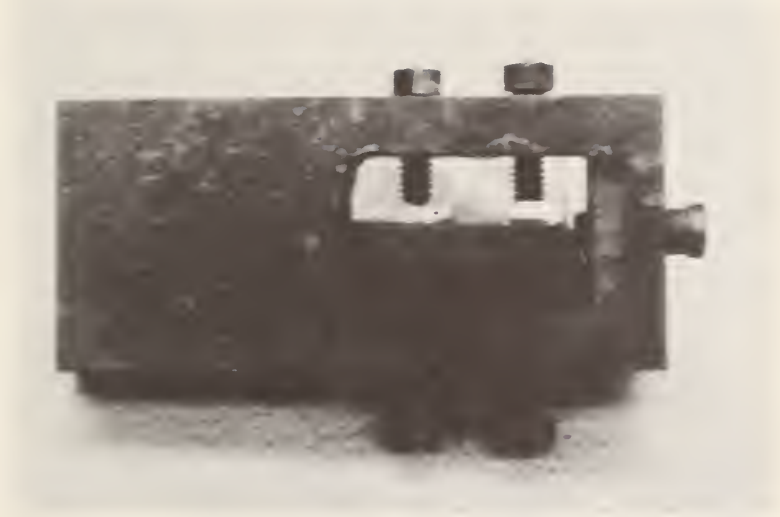
Figure 5. High temperature electrical test fixture

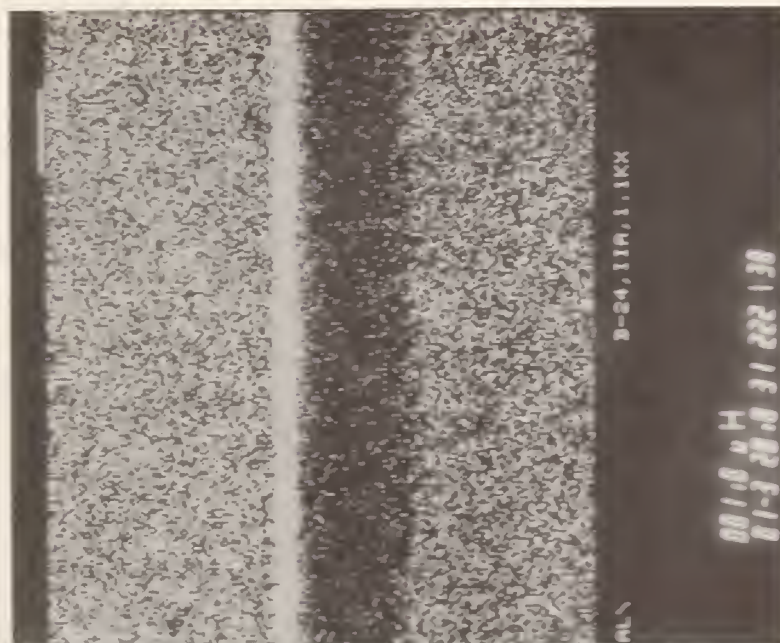
Figure 6. Electron scan of D24 (1100x)
Al highlighted displaying Al_2O_3 phase

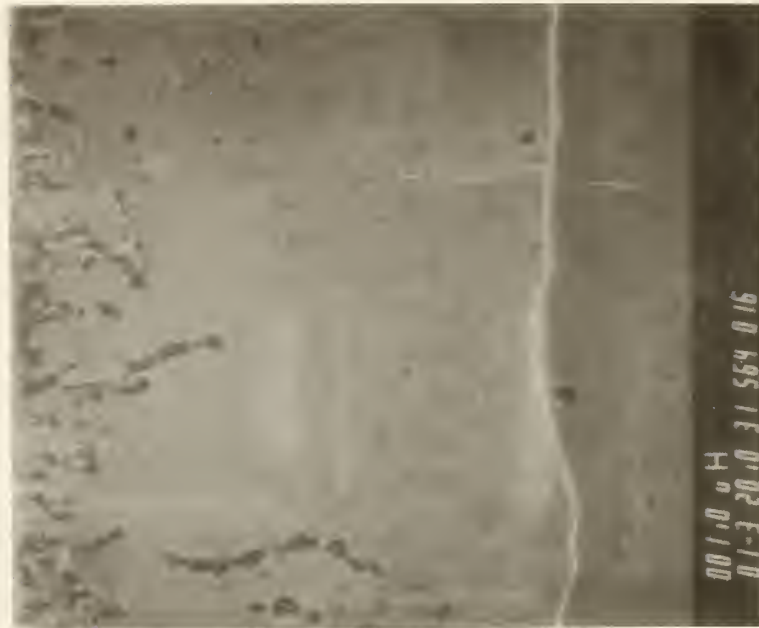
Figure 7. Scanning electron micrograph of D4 (1530x)
 Oxides are penetrating inward from surface
 Heat treated at 1090°C for 50 hours

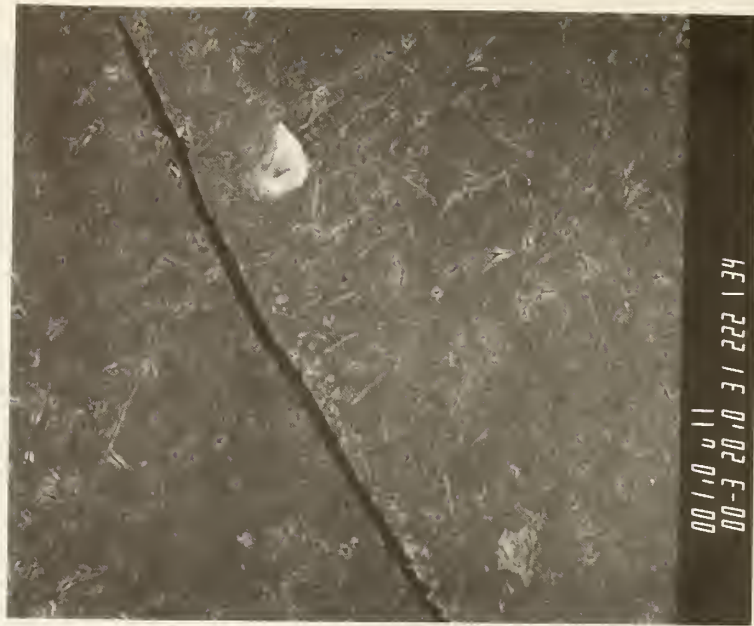
Figure 10. Scanning electron photograph of D14
 Al_2O_3 is dark 1 μm line 580x

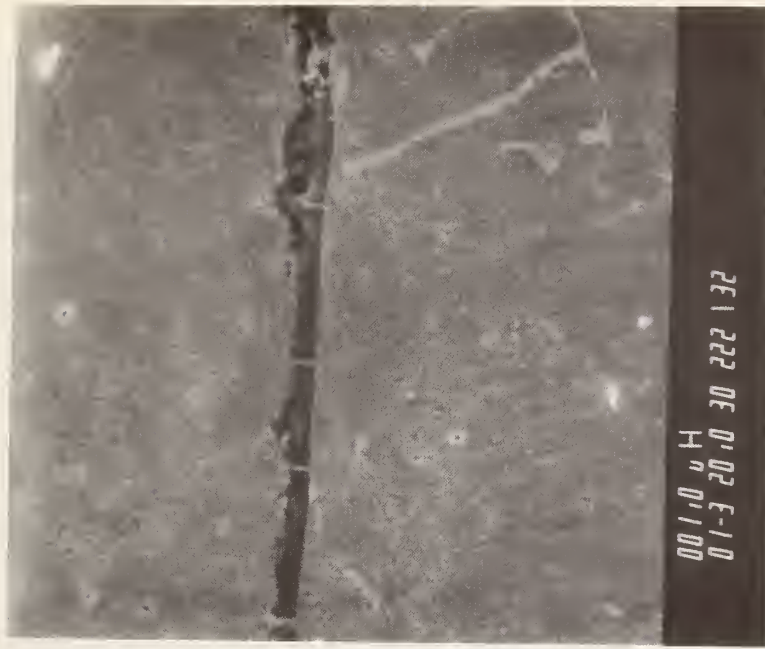
Figure 18. Scanning Electron Micrograph of A19
Note bridging of Al_2O_3 barrier layer with metal

that is, if the iron and aluminum penetration are not significantly less the barrier coating is not working. A scanning electron micrograph is presented in Fig. 18. The photograph at 1000X indicates some damage to the FeCrAlY coating at the interface, but perhaps more significantly it appears that metal bridges are formed through the Al_2O_3 barrier layer. The diffusion data is presented in Table 8 and a second profile in Table 9. The data from Table 8 are also presented in Fig. 19. Again, the cobalt is rapidly diffusing through the FeCrAlY reaching approximately 25% by weight in the b.c.c. phase. The iron concentration is penetrating at approximately 40 μm to quarter of peak height. This is a greater amount than the diffusion in the A40 coupon which had no barrier. Aluminum penetration to quarter height is also approximately 40 μm . It is clear that the Al_2O_3 barrier is not preventing (or slowing down) diffusion of iron or aluminum into the substrate and it is not slowing down cobalt diffusion into the coating. Chromium is probably not a problem in these alloys. The indications are that the coating is being breached by cracks or holes and the impermeability of the Al_2O_3 for Al, Fe, and Co is not being utilized. Perhaps an improvement of the Al_2O_3 coating technique (for both bonding and continuity) coupled with a rigorous inspection technique could yield a useful barrier layer.

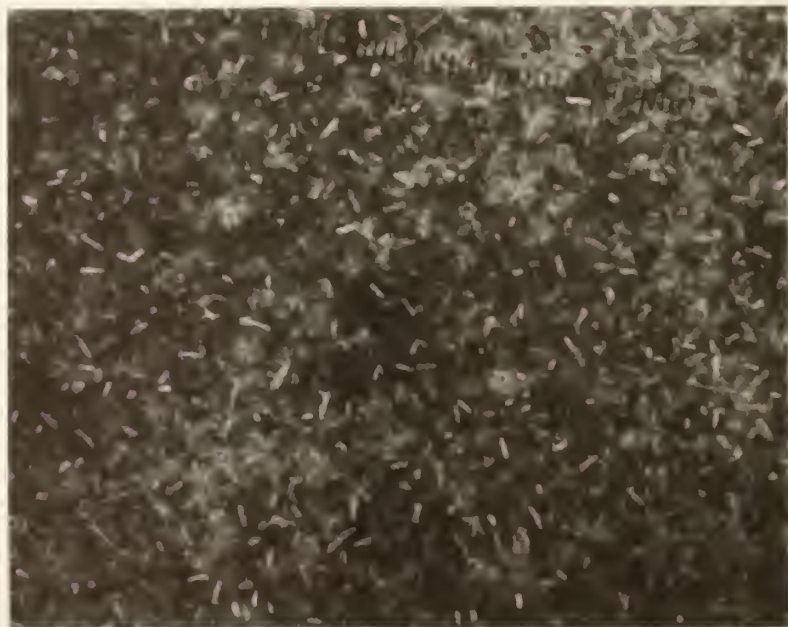
Figure 25. Thermal oxide of sputtered NiCoCrAlY on D8

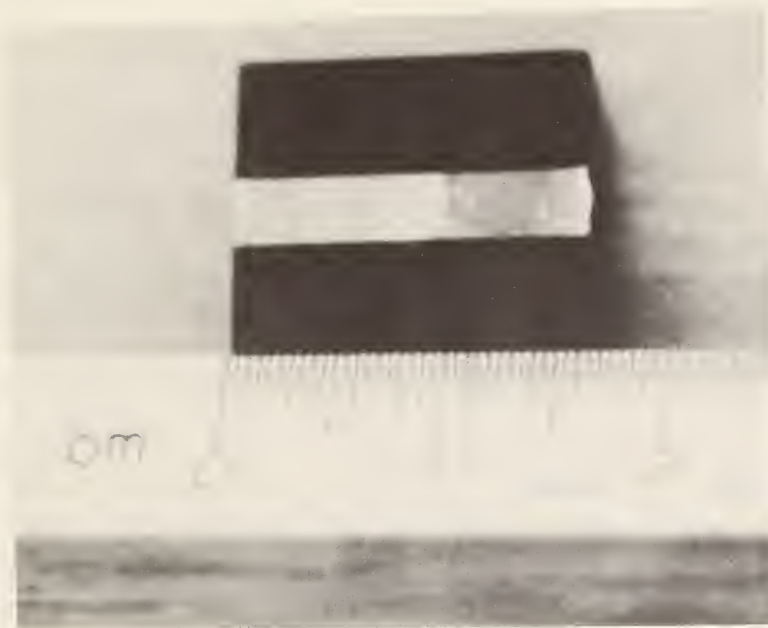
Figure 35. Small test coupon for thin film Pt and Pt 10% Rh
